# The Old Windmill Digital Reconstruction

Brisbane Open House Oct 2018 Architectural History Workshop

This report written by Jay Stocker, School of Architecture University of Queensland

This document has been prepared for the Brisbane Open House 2018 Architectural History Workshop and documents the research, sources and reasoning behind the 3D models of the existing and reconstruction of the Old Windmill that have been constructed.

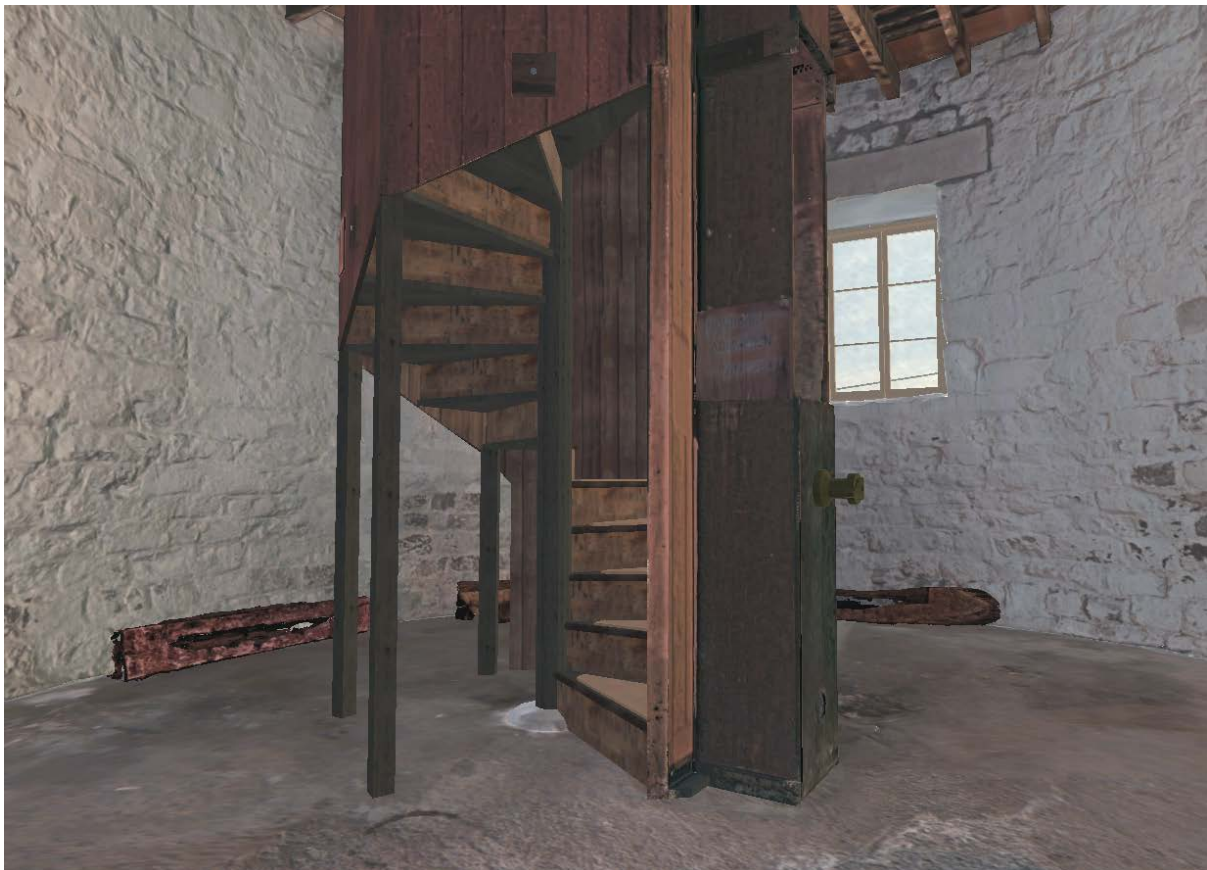
### Central stairwell

This hexagonal timber stairwell dates from the 1862 conversion of the old windmill into a signal tower by John Petrie. It consists of 62 steps, with cedar used for the treads, risers and central axis pole (QSA Col A). It is likely that much of the original cedar timber is still present, though later additions have been made. During the 1988 conservation works strengthening plates and thin hardwood protective tread overlays were added (Marquis-Kyle, 1991). The works from 1988 and 2009 respectively can be identified by stamps on each timber element showing the year. The stairwell has been precisely modelled according to the point cloud scan data.

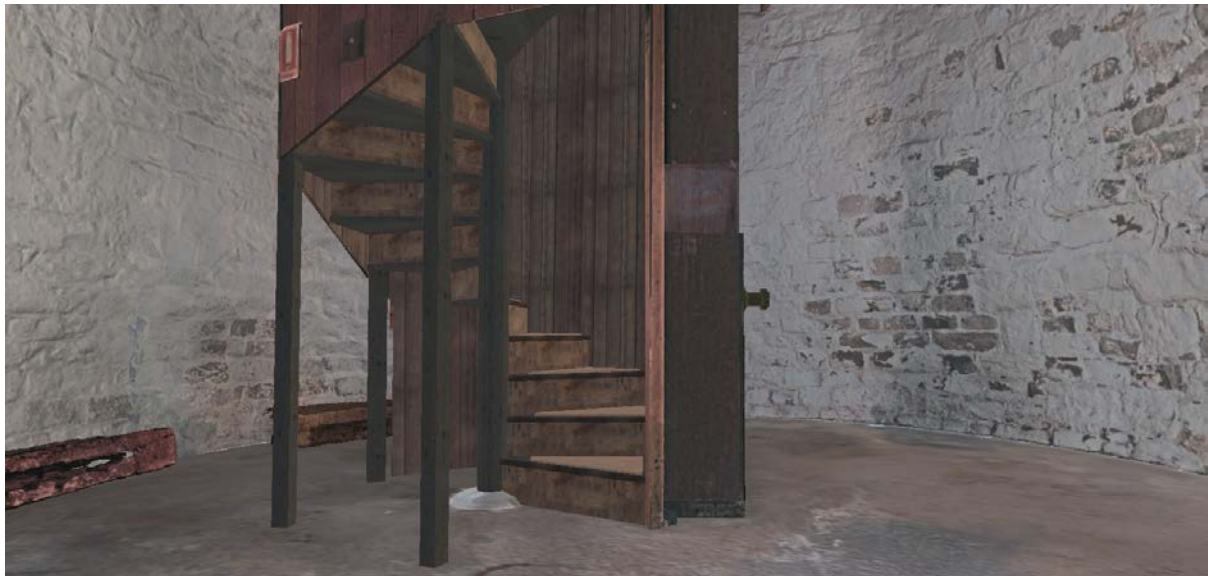
## Ground level interior walls

The ground level interior walls are constructed from whitewashed Brisbane Tuff quarried at the Kangaroo Point cliffs. The foundations are likewise constructed from Brisbane Tuff, and continue down to the bedrock approximately one metre beneath the exterior ground level. The cavity between the interior and exterior stone walls is likely packed with rubble (BCC Heritage, 1996). The irregular interior surface of the ground level walls has been generated from point cloud scan data.

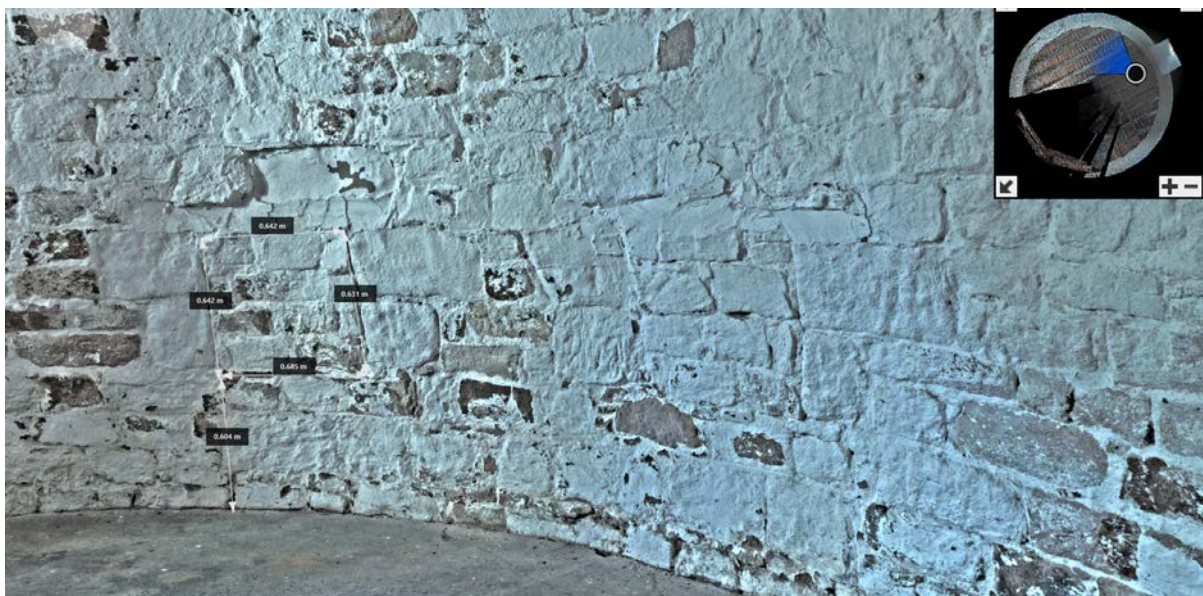
## Filled openings in the ground level walls.

Two square filled openings are visible in the ground level walls: located approximately 600mm above the ground floor slab and measuring approximately 650mm square. Above the openings the whitewashed outlines of lintels are visible. The digital model confirms that these openings are parallel to an axis line drawn out from the centre of the tower to a point directly between the two openings. The line of this axis matches with the treadmill alignment determined by Janet Hogan (Hogan 1971) and also matches with the rectangular outline of the treadmill visible on the 1940 Dixon map of Brisbane town (Dixon, 1840).

No physical remains of the treadmill have been discovered to date. The only known physical evidence for its existence is the two square filled openings are visible on the ground level walls. These openings are located approximately 600mm above the ground floor slab and measuring approximately 650mm square. Above the openings the whitewashed outlines of lintels are visible. The digital model confirms that these openings are parallel to an axis line drawn out from the centre of the tower to a point directly between the two openings. The line of this axis matches with the treadmill alignment determined by Janet Hogan based on contemporary maps (Hogan, 1971).

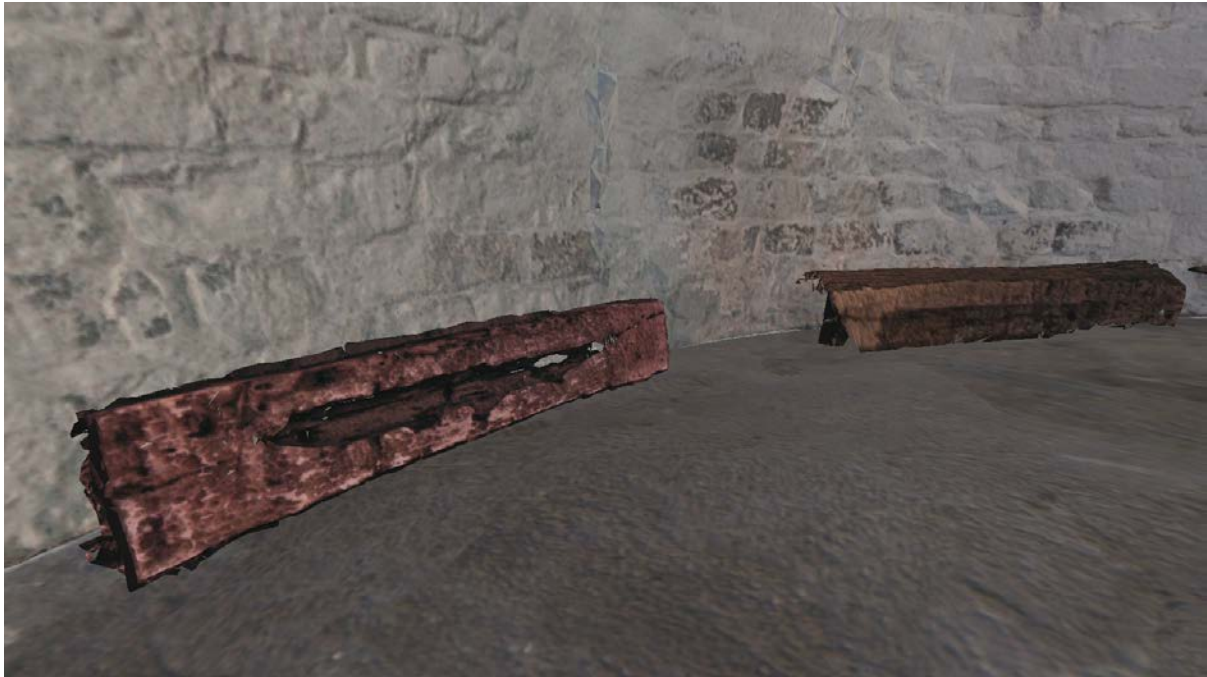
### Ground level existing timber lintels

The existing decayed timber lintels resting on the concrete ground level floor were removed from above the ground level entry door and window in 2009 (BCC Heritage). These lintels were replaced with steel because their structural integrity had been compromised by termite damage.

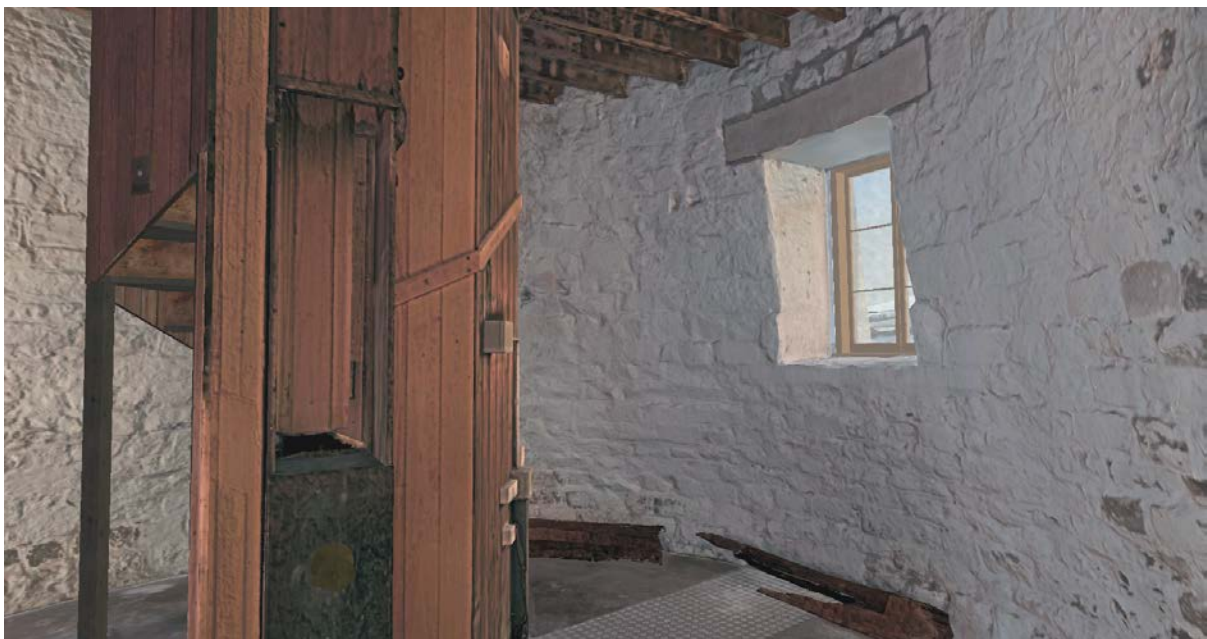
### Ground level window

The ground level window opening dates from the original construction of the windmill, though the casement has likely been replaced at least once. The window opening has a sandstone lintel and sill externally, beneath the protective render. The internal timber lintel was recently replaced with a new steel lintel due to termite damage.

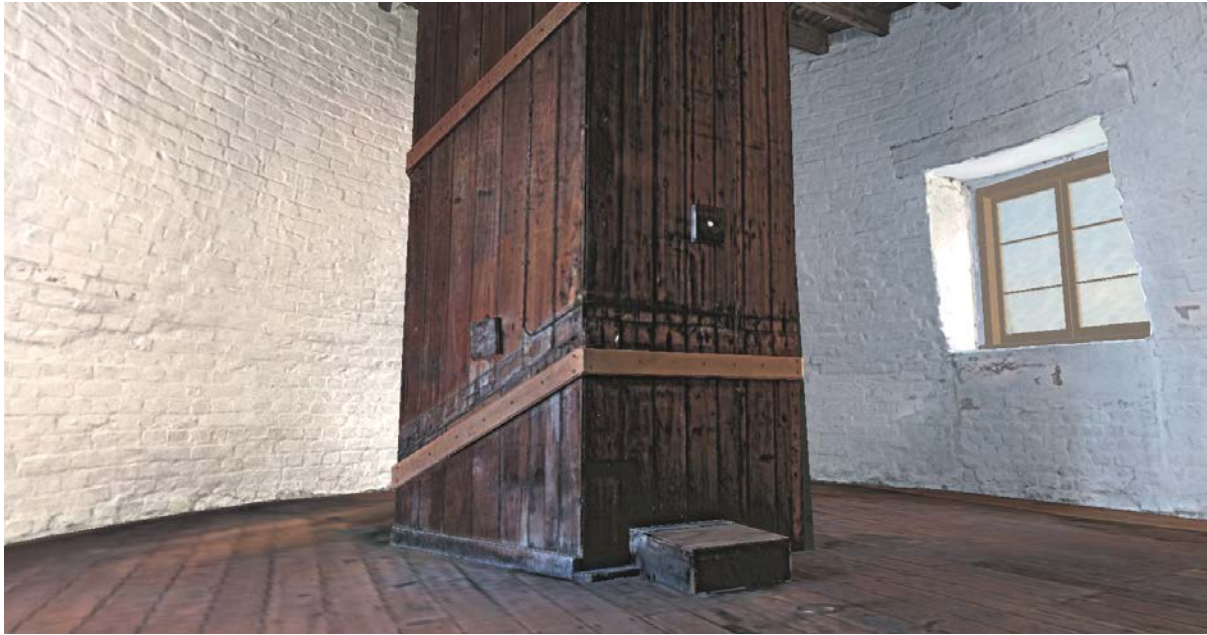
### Level one timber floor

The level one timber floor in its existing configuration dates from the 1862 conversion of the old windmill into a signal tower by John Petrie, who renewed all four timber floors of the tower, from ground level to level three (QSA Col A). The level one floor sits on a rebate at the top of the ground level walls, suggesting it is at the same level as the original “stone” floor of the windmill, which housed the two millstones (Whitmore, 1989). This floor has been modelled by tracing the point cloud scan data.

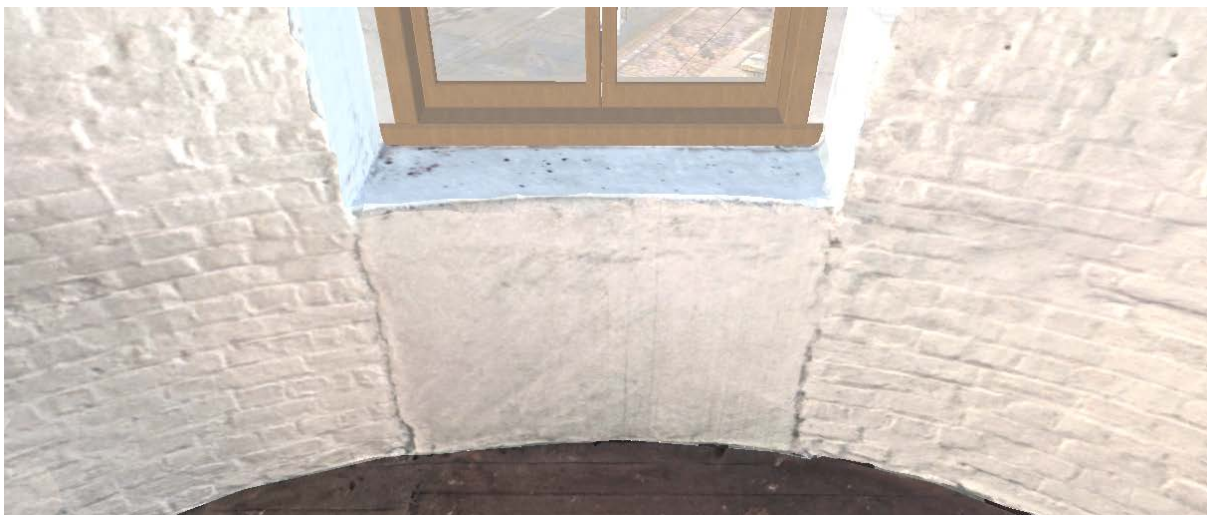
### Level one windows

The level one windows were probably once doors giving access to the reefing stage platform around the tower, evidenced by the brick infill beneath the window sills visible on the photos of when the exterior render was removed in 1988 (Allom Lovell Marquis-Kyle, 1988). The openings certainly date from the original construction of the windmill, evidenced by the original timber lintels visible internally above the openings. The casements have been replaced at least once.

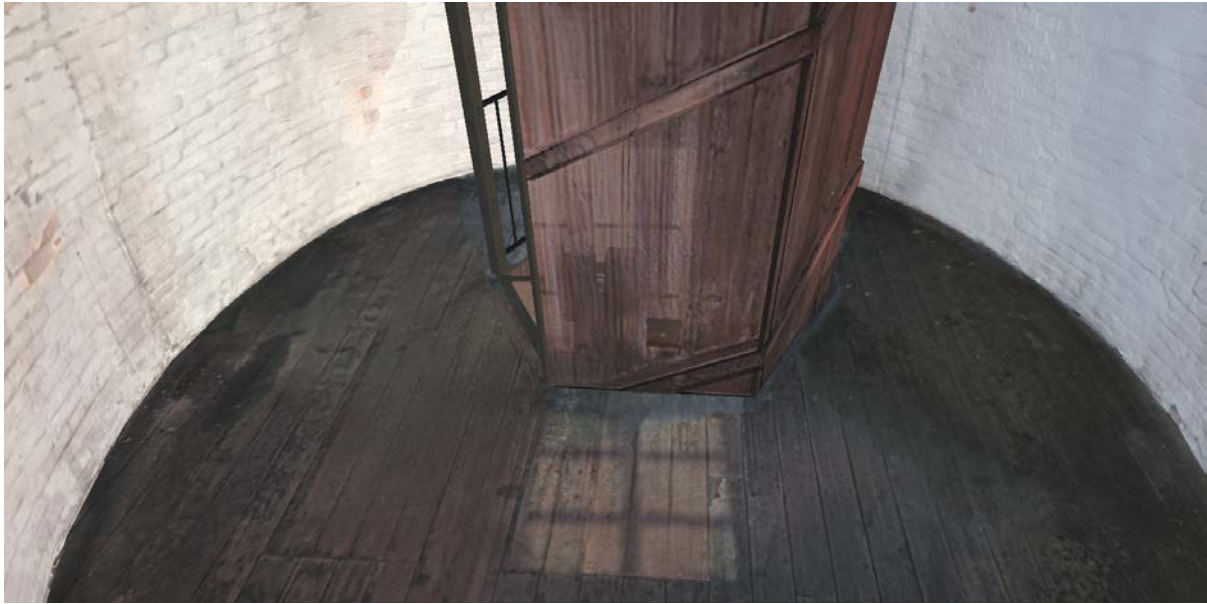
### Level two timber floor

The level two timber floor in its existing configuration dates from the 1862 conversion of the old windmill into a signal tower by John Petrie, who renewed all four timber floors of the tower, from ground level to level three (QSA Col A). The level two floor sits on a rebate in the brickwork, suggesting it is at the same level as the original “bin” floor of the windmill, from which the wheat and grain was fed down a chute to the millstones below (Whitmore 1989). This floor has been modelled by tracing the point cloud scan data.

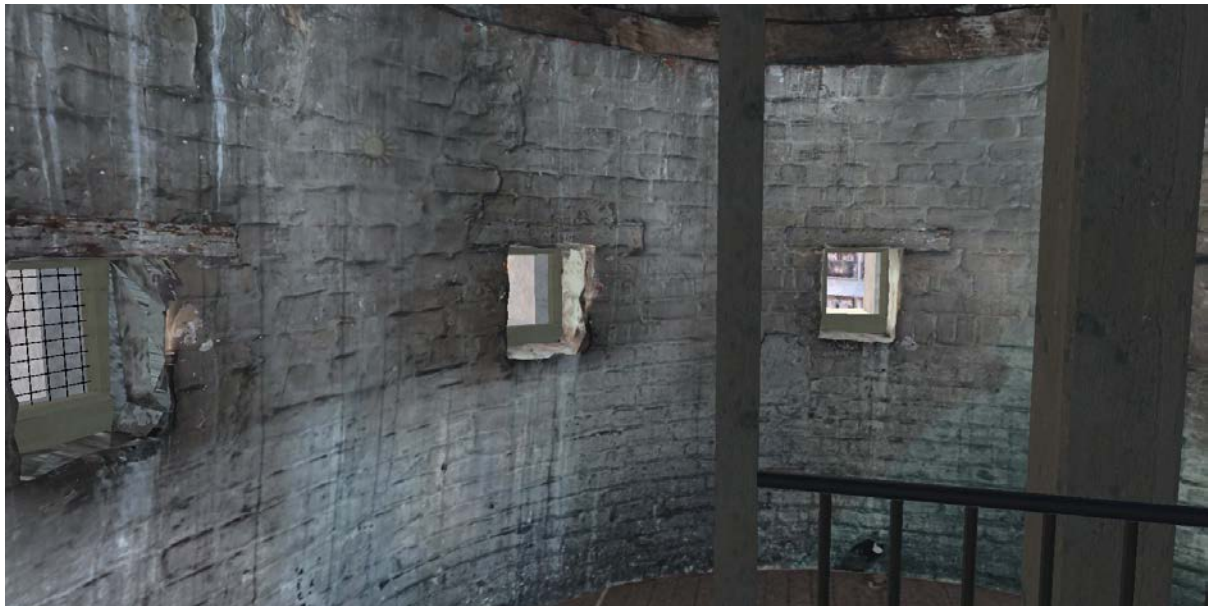
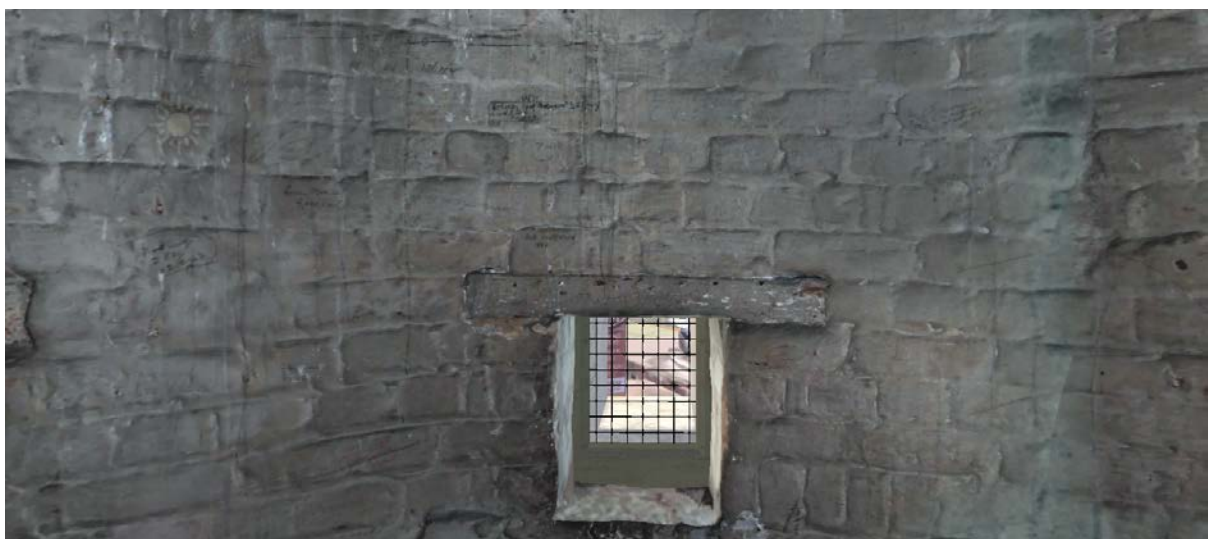
### Level three windows

The level three window openings are unlike the other windows: they are much smaller, not glazed, and formed by the gaps between the exterior sandstone blocks of the topmost cylindrical section of wall above the tapering brick walls (Allom Lovell Marquis-Kyle, 1988). These window openings have timber lintels internally, some of which are covered with pencil graffiti.

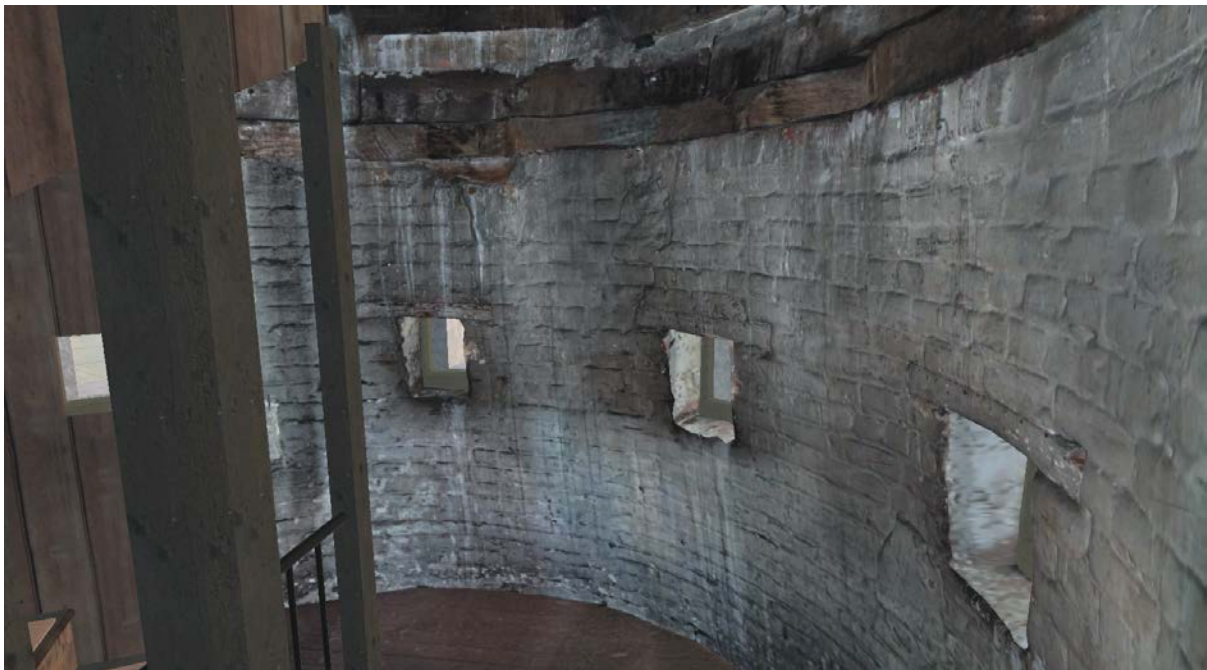
### **Cylindrical top section of the tower (level three walls)**

The Old Windmill possesses an unusual feature: the tapering brick walls are topped with a cylindrical ring of brickwork, faced externally with sandstone blocks. Ray Whitmore has theorised that this section was added as an afterthought to increase the height of the tower, so that an additional “dust” floor (level three) could be added (Whitmore 1989). This theory is supported by the fact that there is no rebate in the internal brickwork walls to support the level three floor, suggesting it had been completed before it was decided to raise the height of the tower.

“In the Brisbane mill the stone floor (level one) rested on top of the lower stone section (ground level), with doors leading out onto the reefing stage. A rebate in the brickwork 3.2 metres higher up the tower supported what is presumed to have been the bin floor (level two). This would have left a clearance of 4.27 metres to the bottom of the curb if it had been fitted on top of the conical section of the tower. There would have been insufficient headroom for an additional floor... By raising the curb a further 1.25 metres it was possible to add a “dust” floor with 2.13 metres of clearance to the curb while still leaving 3.5 metres of headroom to the bin floor. The advantage of a dust floor is that it prevents dirt, grease and rain falling onto the bin floor, and it can also house the mill hoist – which is an advantage inside the tight confines of the tower. However, if construction had been completed to the original curb level before it was decided to increase the height of the tower there would be no rebate incorporated in the brickwork to support a dust floor. This is indeed the case in the Brisbane mill. The builders also had to provide some lighting to the new floor without seriously weakening the top of the tower and their solution, it is suggested, was to insert the ring of tiny windows in the additional masonry, giving the Brisbane mill tower its unusual, characteristic appearance.” (Whitmore, 1989)

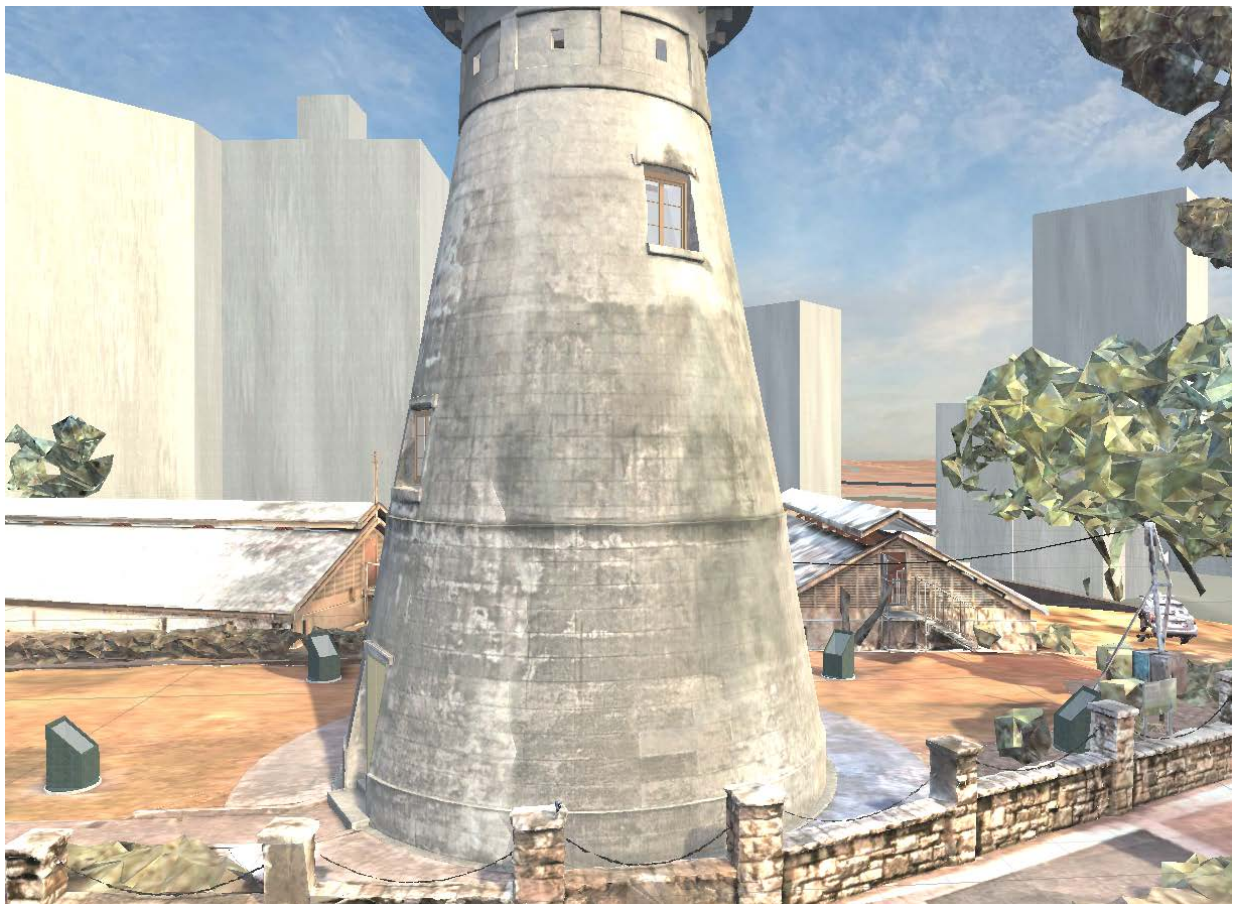
### **The exterior render**

The exterior of the Old Windmill is rendered to protect the sandstone blocks and brickwork from weathering. The conical brickwork section has been rendered in all historical photos of the tower, and by around 1902 the entire exterior had been rendered, including the sandstone sections (BCC Heritage, 1996). In 1950 the old render was removed and the entire exterior was re-rendered as part of controversial renovations (BCC Heritage, 1996). Most recently the render was also completely stripped away and renewed during the 1988 conservation (Allom Lovell Marquis-Kyle, 1988).

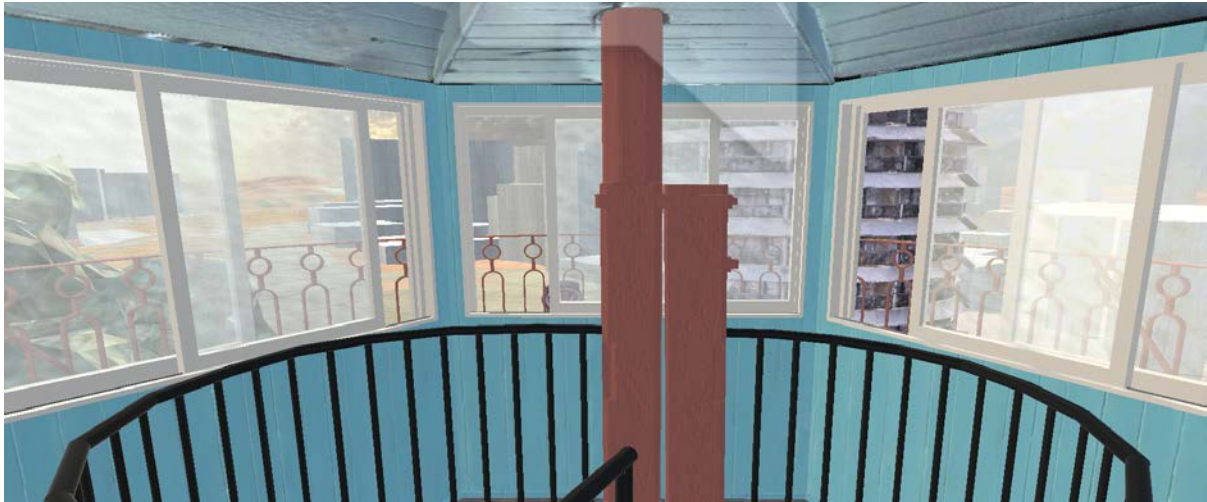
### The top level observatory room

This hexagonal observatory room dates from the 1862 conversion of the Old Windmill into a signal station by John Petrie. Most of it appears to be original fabric from 1862, such as the timber floor and internal linings, though the roof sheeting was replaced in 1982 (BCC Heritage, 1996). The original casement windows were replaced with louvered windows during the controversial 1950 renovations (BCC Heritage, 1996), but re-instated during the 1988 conservation (Allom Lovell Marquis-Kyle, 1988).

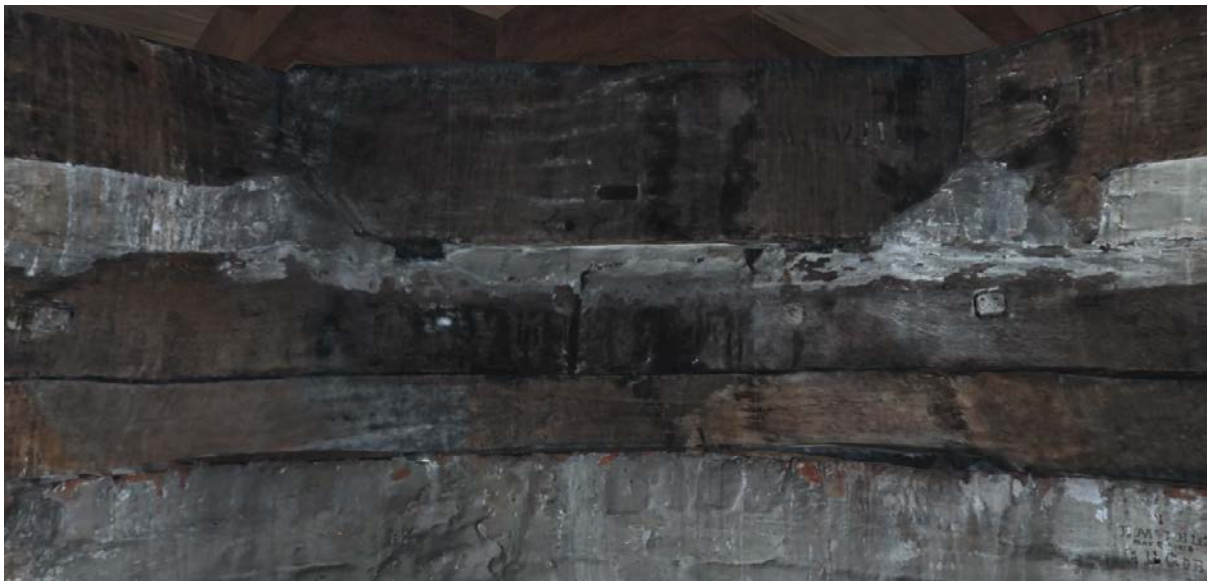
### The existing curb and cap frame

These timbers that form the top section of the internal level three walls are actually the remains of the original curb and cap frame of the windmill: the bottom layer is the curb support, the middle layer the curb itself (the levelled top of the tower mill) and the top layer was the rotating cap frame, which was supported by rollers sitting on the curb surface. Wear marks from the truckles (rollers) can be seen on the visible face of the curb. The faces of these timbers are etched with roman numerals to mark the order in which they were to be assembled (Whitmore, 1989). These timbers are local hardwoods, which suggests that this windmill machinery was constructed with significant skill here in Brisbane (BCC Heritage, 1996). It appears that during the 1862 conversion of the windmill into a signal tower, the cap frame was simply cemented into place on top of the curb.

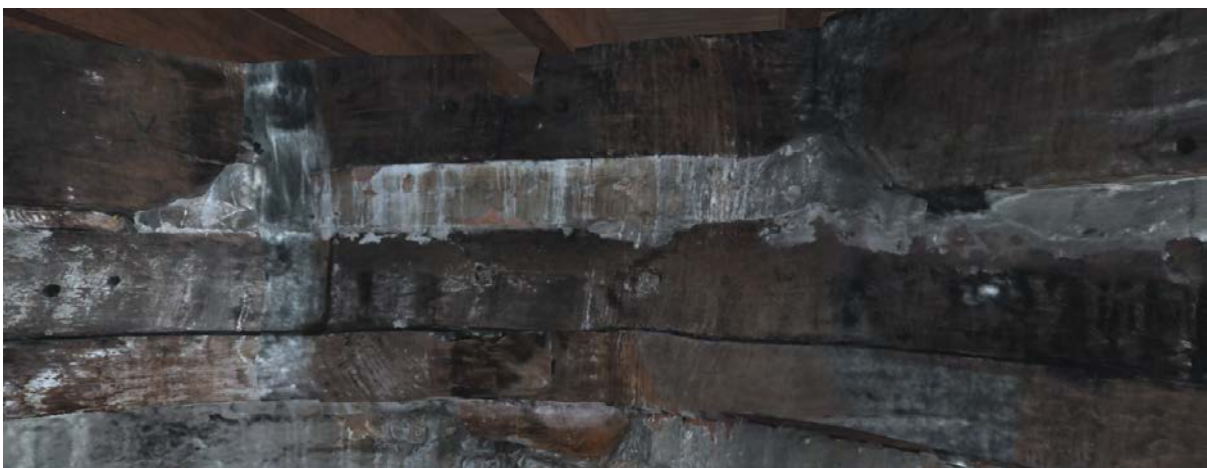
The mortise where the sprattle beam (which supported the vertical shaft) was removed is clearly visible. Site investigations suggest that the corners of the rectangular cap frame, including the shear beams (which supported the fantail) were cut away. Any surviving physical evidence of the toothed rack which would have run around the outside of the curb is impossible to examine because the exterior brickwork is laid closely against the outside face of the curb.

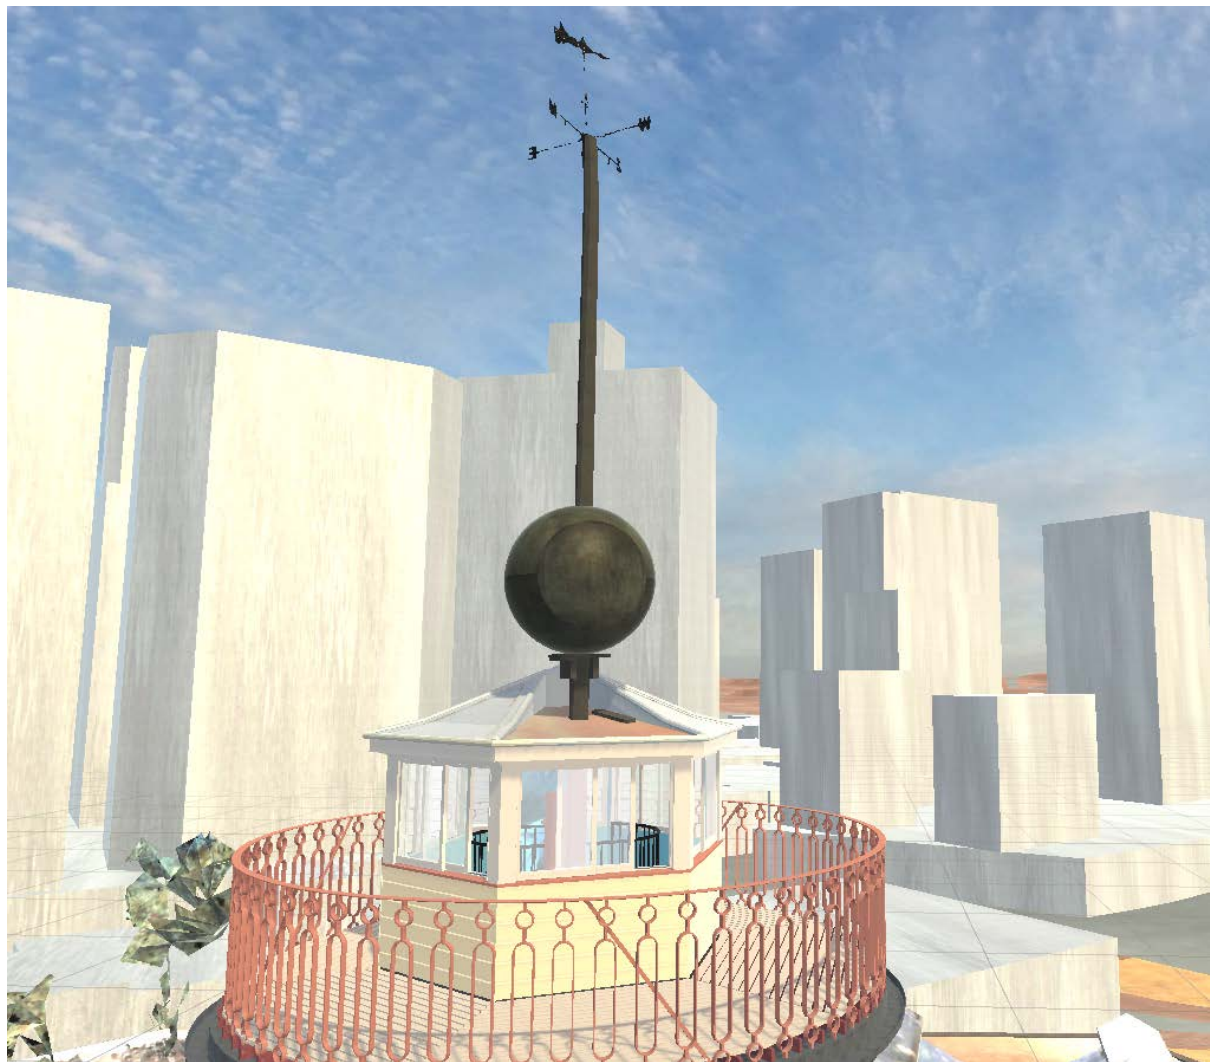
### **The time ball**

This copper time ball was raised to the top of the mast, and dropped at 1pm every day to enable people to set their watches (Hogan, 1971). The time ball was installed during the 1862 conversion of the windmill into a signal tower. Use of the time ball was discontinued in 1866 and replaced with a time gun (cannon) adjacent to the tower (Hogan, 1971). The copper time ball was removed, cleaned and eventually re-assembled and reinstalled in 1982 (BCC Heritage, 1996). The time ball and mast have been modelled according to point cloud scan data.

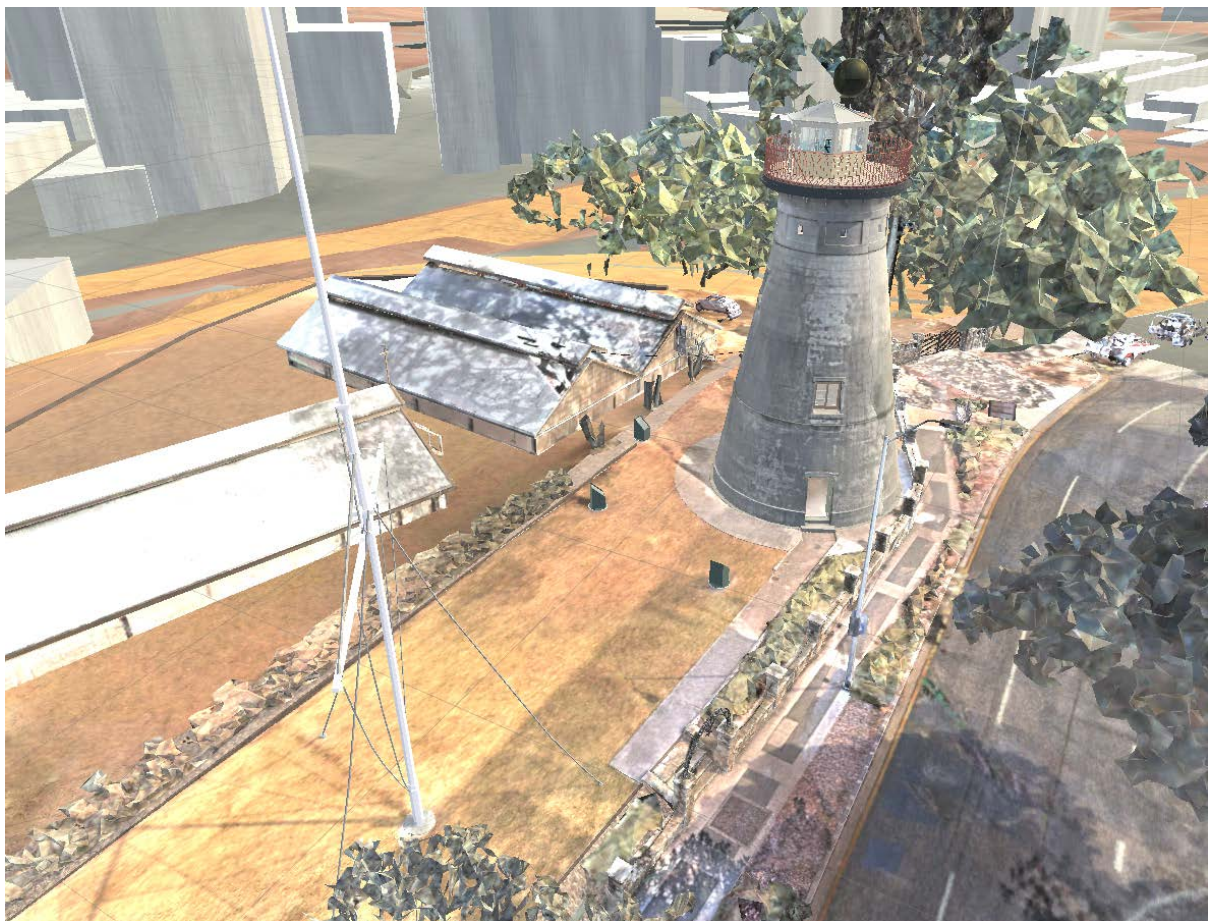
### **The stone wall along Wickham Terrace**

This stone wall along Wickham Terrace dates from 1926, designed by the city architect A H Foster, as part of "beautification" works around the tower (BCC Heritage, 1996). The wall is constructed from Brisbane Tuff and wrought iron. The irregular shape of the wall has been generated from point cloud scan data.

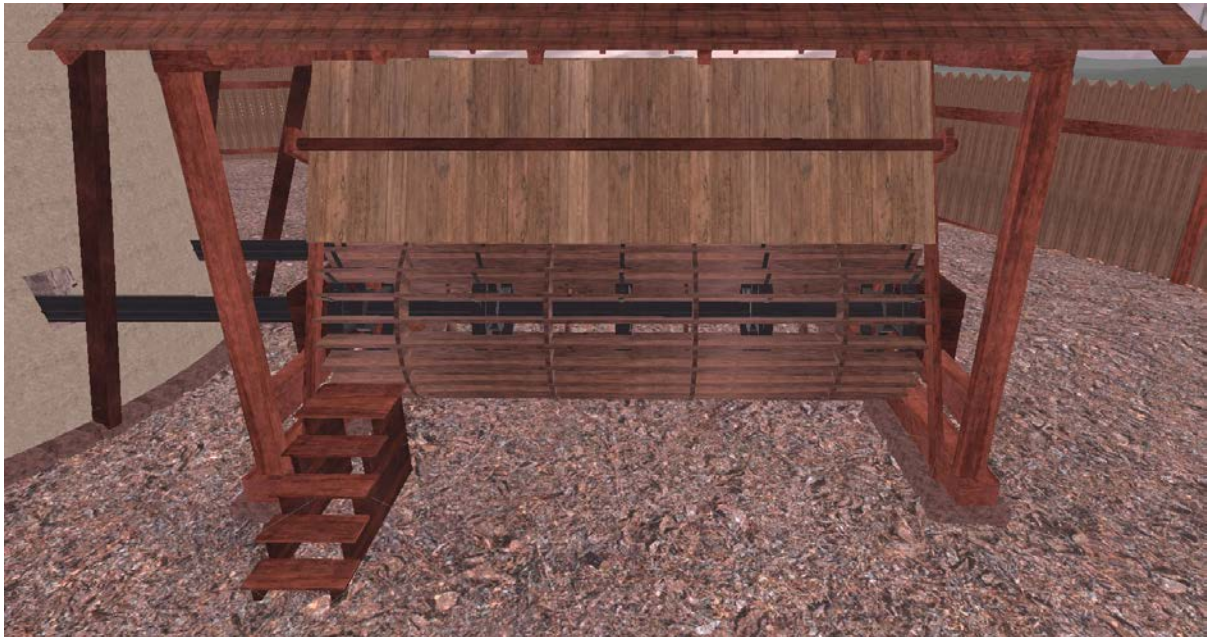
The standard construction for the treadmill wheel would have been twenty-four timber steps (House Histories, 2017) around a central shaft, looking something like a “chaff cutter” likely with a guard screen of timber boards, and a handrail to hold on to (Whitmore, 1989). According to one account, “five steps” were climbed onto the treadmill, which suggests there were no floorboards alongside the length of the treadmill wheel (House Histories, 2017). This means that any convicts losing their feet would have merely fallen to the ground, instead of regularly having their feet mauled between the floorboards and the descending wheels. There is actually only one recorded instance of an exhausted convict meeting his death upon the treadmill, and this was likely due to being unluckily dragged underneath the wheel.

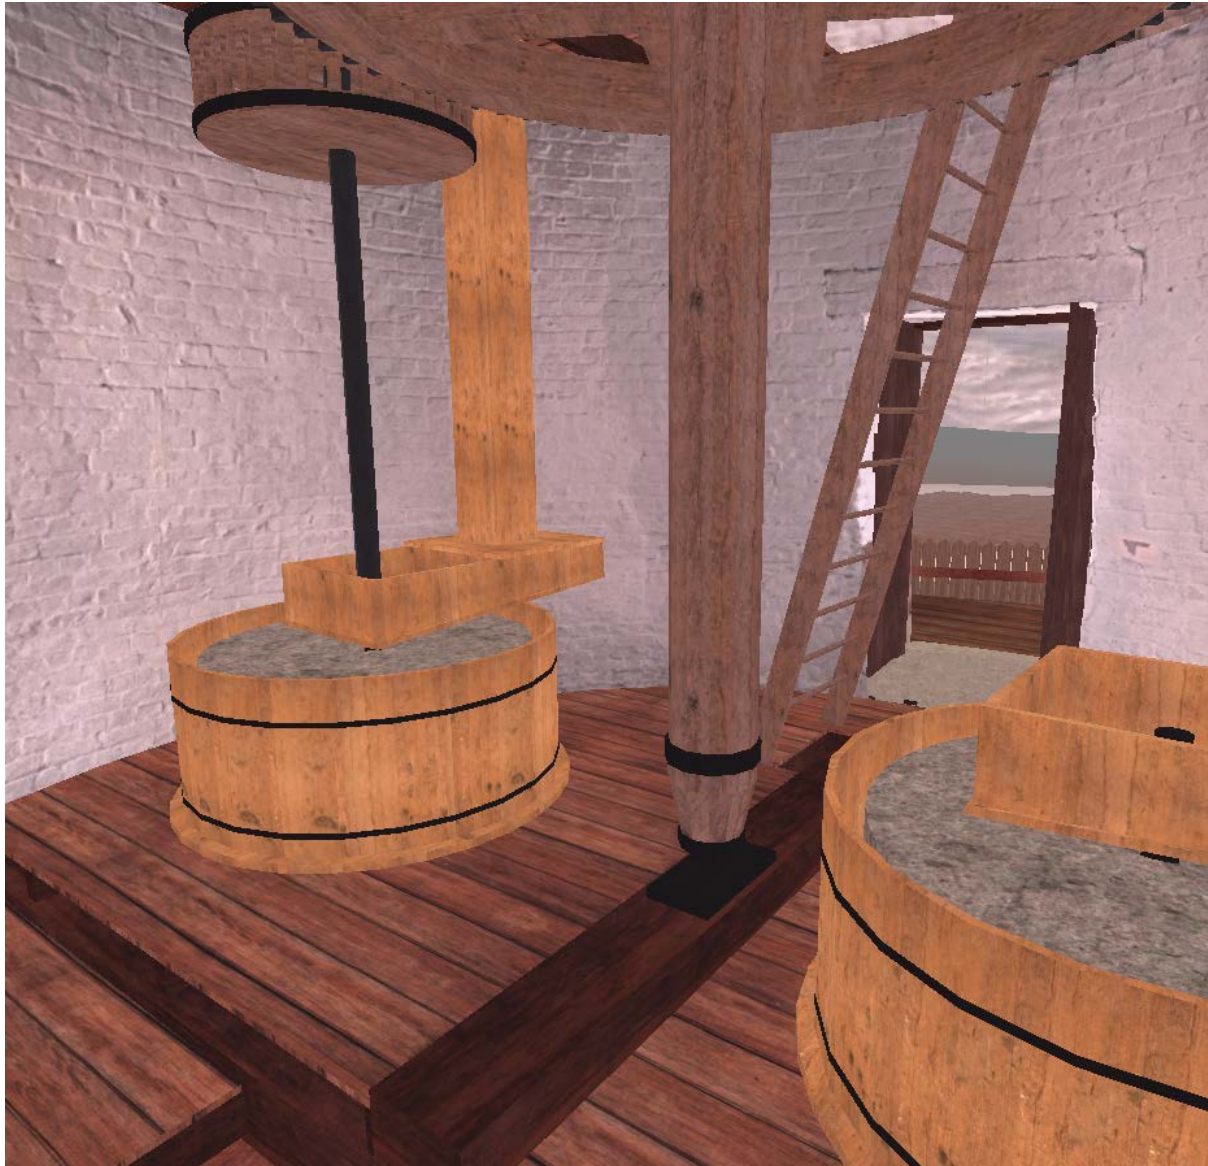
### **The stone floor (level one)**

The stone floor of the windmill (level one) housed the two millstones, with the great spur wheel above. This floor also gave access to the exterior reefing stage platform around the tower through the two doorway openings. The reconstruction assumes that the structure of the timber floor was supported on the rebate at the top of the ground level walls, at the height where the brickwork walls begin, at the same level as the current level one floor.

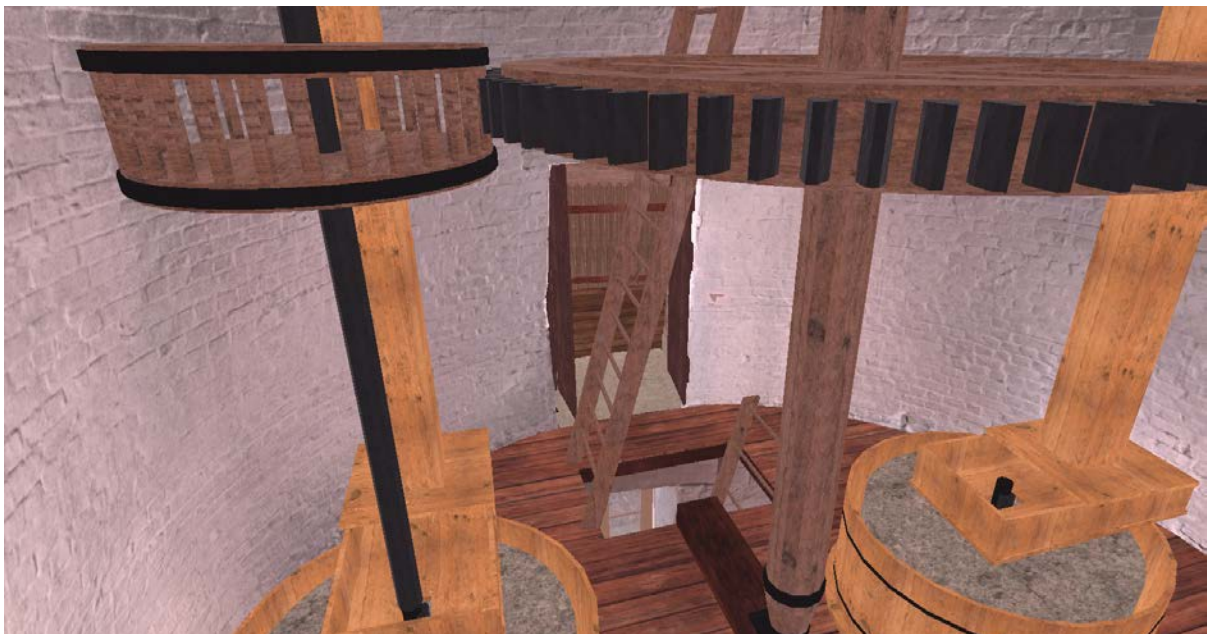
### **The great spur wheel and stone nut**

The function of the machinery on this level was to transfer the rotation from the central spinning shaft to the runner millstone. The great spur wheel was fixed to the central rotating upright shaft, with a toothed rack around the outside that meshed with the teeth of the stone nut, which drove the spindle of the runner millstone.

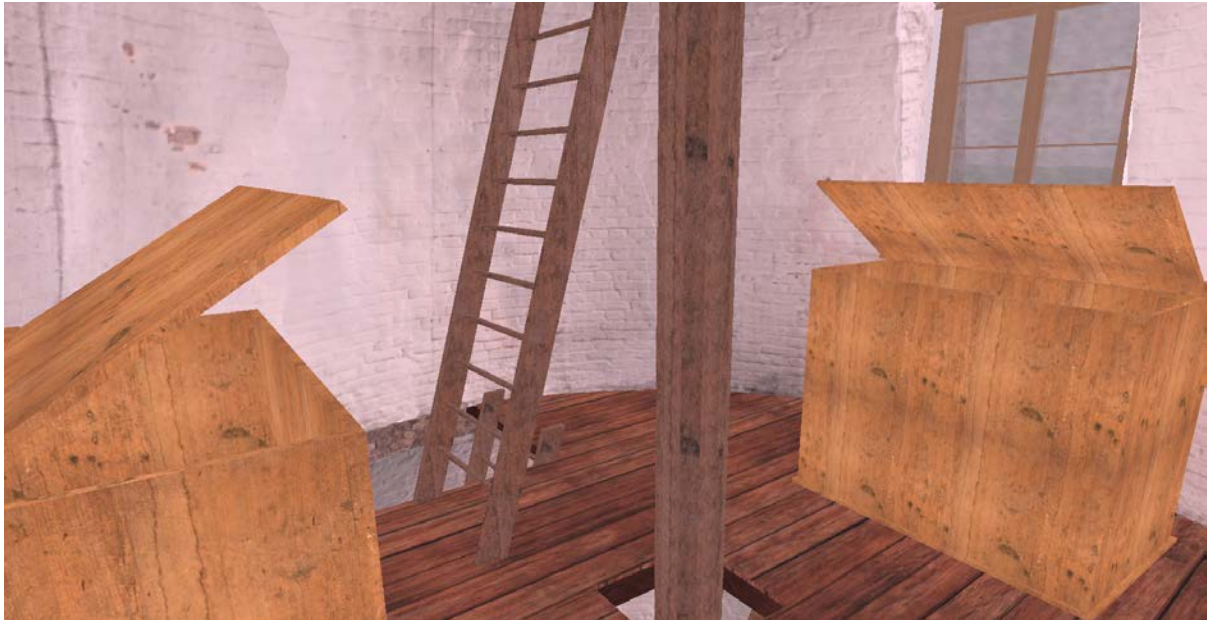
### The bin floor of the windmill (level two)

The bin floor (level two) housed the two grain bins, into which corn or grain was poured, to be gravity fed through chutes into the millstones to be ground. The sacks of grain were hoisted up to this level through the trapdoors using the sack hoist on the level above. The reconstruction assumes that the structure of the timber floor was supported on the existing rebate in the brickwork wall, at the same level as the current level two floor.

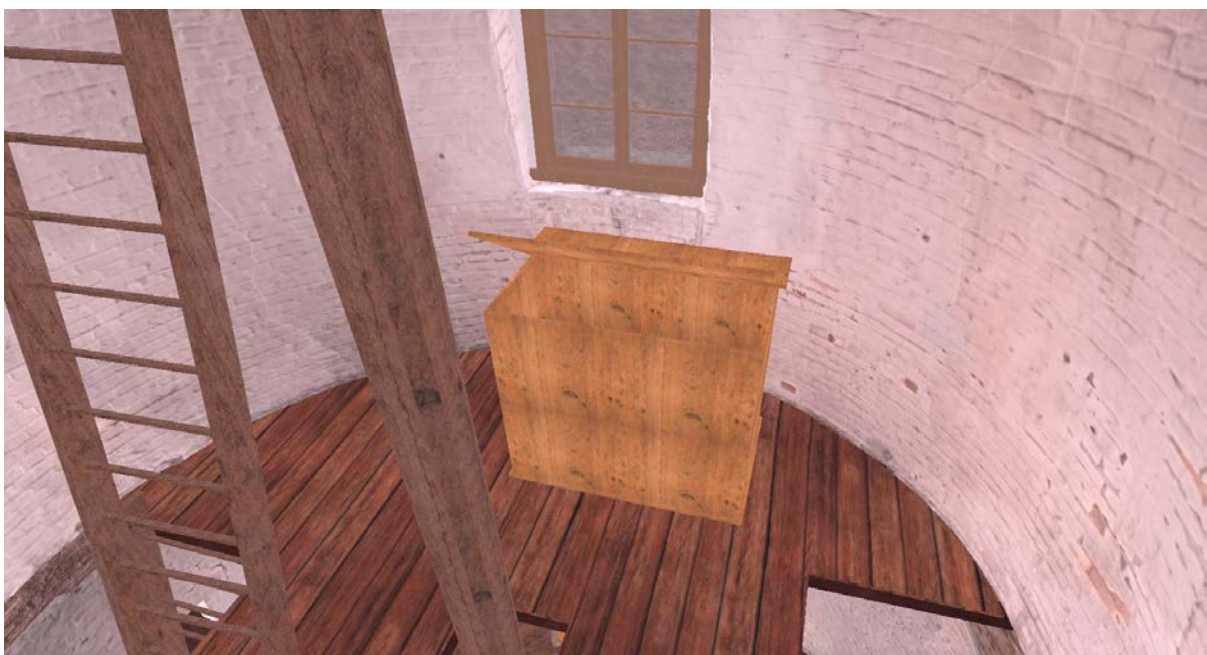
### The grain bins

After the maize and wheat grown in the colony was harvested, the kernels of maize and the wheat grains needed to be manually separated from the inedible husks. Sacks of grain and corn kernels were then transported up to the windmill, and hoisted up to the bin level and poured into the grain bins to be fed to the millstones below.

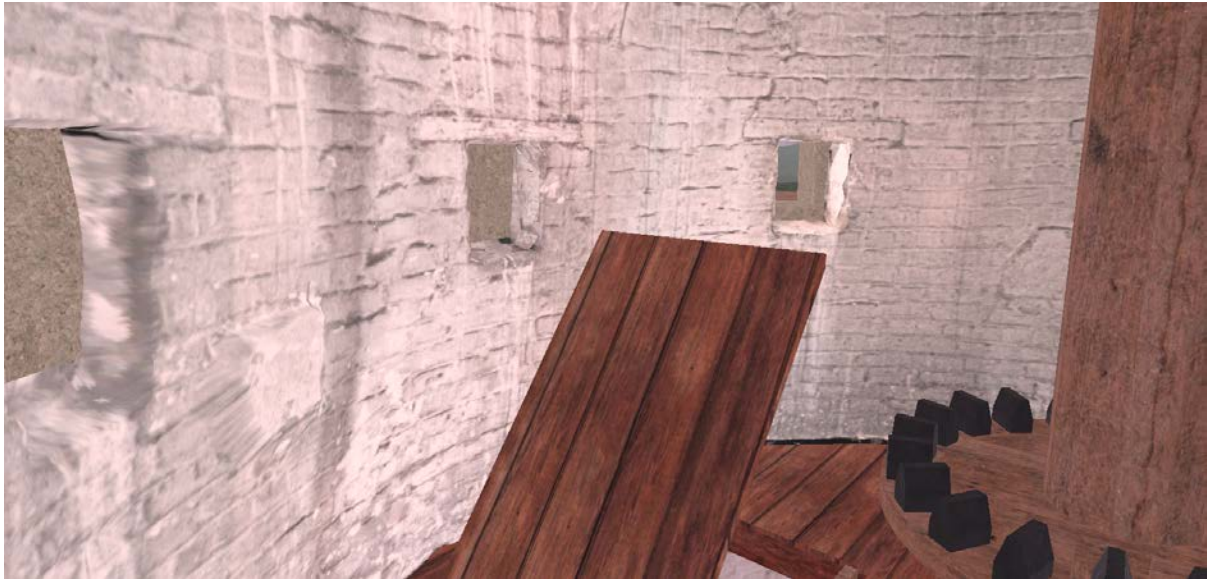
### **The dust floor (level three)**

The dust floor (level three) would have protected the milling mechanisms below from rain and dust blown in through the cap roof of the tower. It is likely that this level also housed the sack hoist machinery for hoisting sacks of grain up to the bin floor on level two. This timber floor does not sit on a rebate in the brickwork: there are joist pockets knocked into the walls instead. This suggests that this level was added as an afterthought, that the decision was made to increase the height of the tower after construction had already progressed past this level (Whitmore, 1989).
