# The Old Windmill Digital Reconstruction

Brisbane Open House Oct 2018 Architectural History Workshop

This report written by Jay Stocker, School of Architecture University of Queensland

This document has been prepared for the Brisbane Open House 2018 Architectural History Workshop and documents the research, sources and reasoning behind the 3D models of the existing and reconstruction of the Old Windmill that have been constructed.

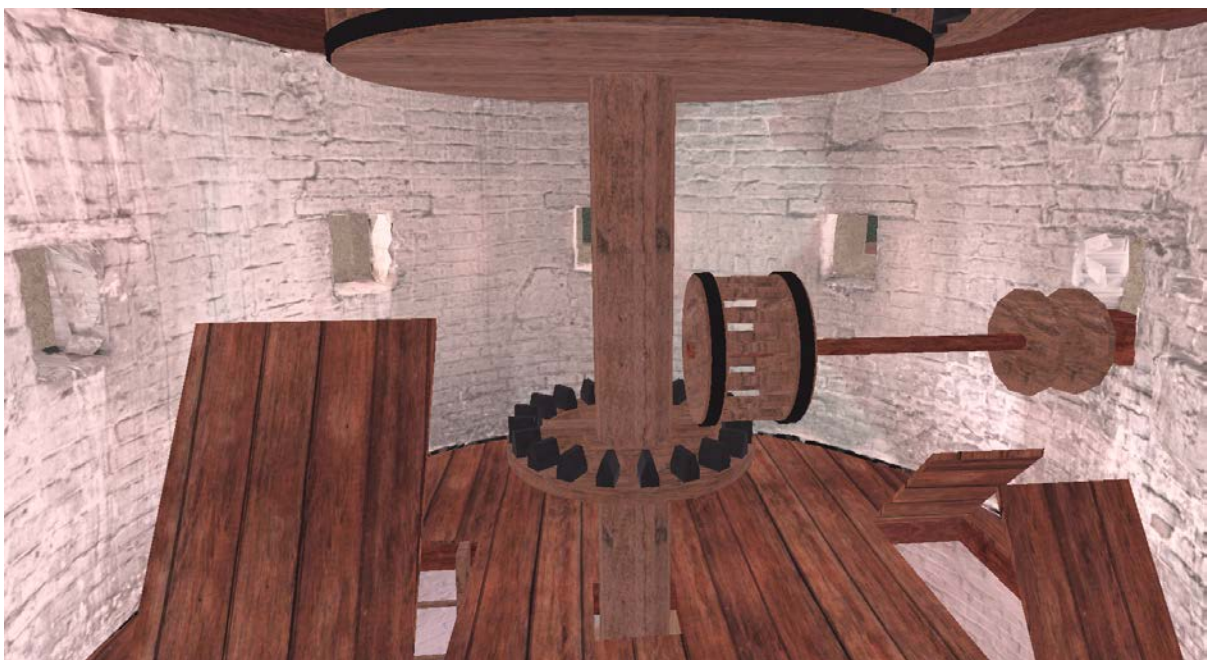
### **The sack hoist machinery**

The sack hoist was a useful piece of machinery that allowed sacks of grain to be hoisted up to the bin floor on level two, from the ground floor. The sacks were tied to a rope that was wound up by the rotation of the upright shaft from the sails, gradually lifting the sacks.

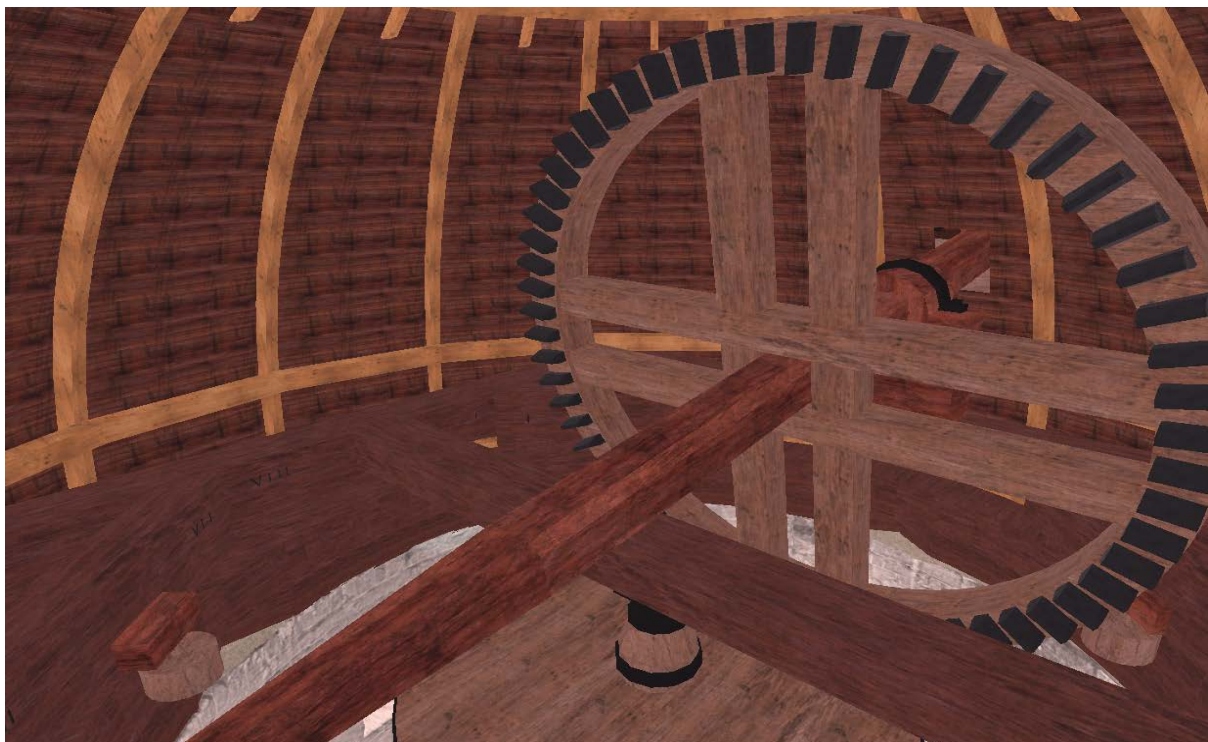
### The brake wheel

The brake wheel was fixed to the windshaft, and functioned to transfer the rotation from the windmill sails to the central upright shaft, via the wallower, which was fixed to the upright shaft. It is known as the brake wheel because a strap mechanism allowed the miller to apply friction to slow the rotation of the wheel from below. The sails of the windmill were joined to the heavy windshaft. The windshaft was mounted on the cap frame with socket bearings, allowing it to turn with the rotation of the sails.

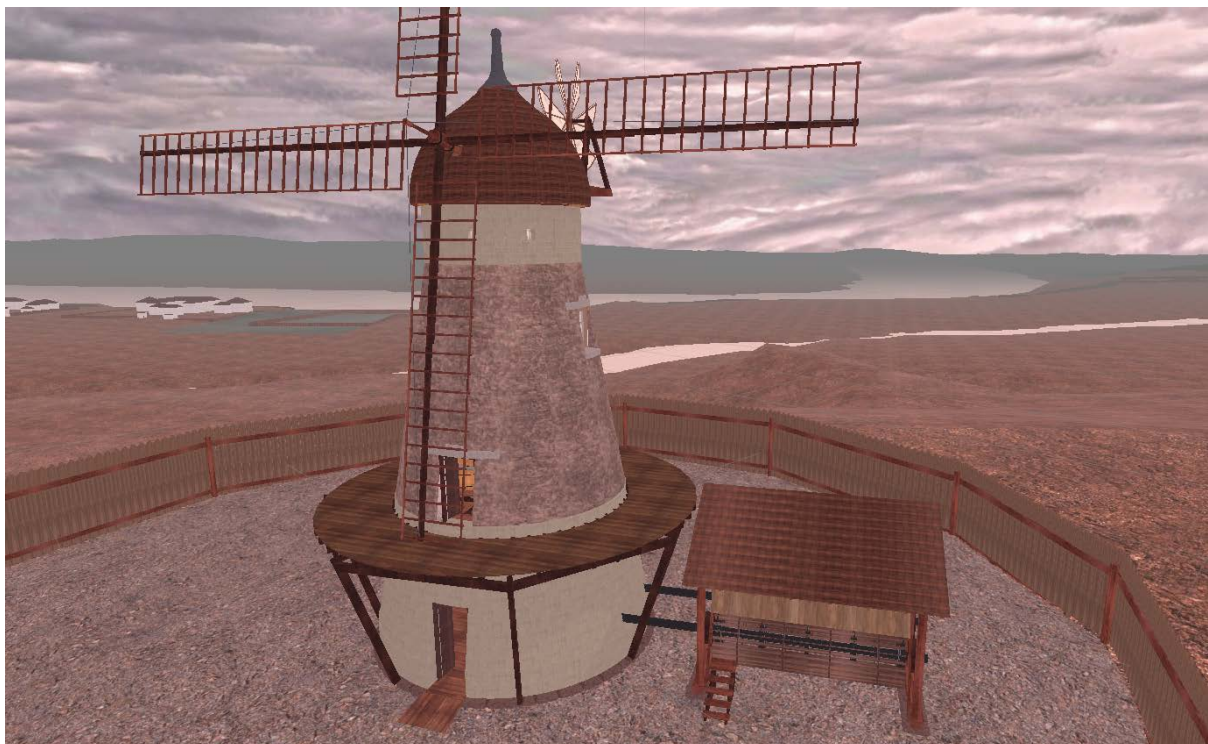
### **The cylindrical top section of the tower**

The exterior sandstone block walls around the ground level of the tower have been reconstructed based on the photographs taken by Richard Stringer during the 1988 conservation works, when the external render was completely stripped away (Marquis-Kyle, 1988). On these photographs, regularly spaced joist pockets around the exterior are visible, which would have housed the joists supporting the external reefing stage platform. Also visible are the external sandstone lintels and sills at the door and window openings.

The tapering brick walls make up most of the height of the conical section of the windmill, from the base of level one, to the base of level three. The brick walls sit on the stone walls of the ground floor, and the construction is at least double brick, perhaps with a filled rubble core. The exterior was not initially rendered. The convict-made bricks are visible on the interior, beneath a whitewash. The exterior brickwork has been reconstructed by copying the interior brickwork pattern.

The tapering brick walls are topped with a cylindrical section of walls, faced externally with sandstone blocks, with brickwork on the interior. The exterior sandstone blocks have been reconstructed based on the photographs taken during the 1988 conservation works, when the external render was completely stripped away (Marquis-Kyle, 1988). Likely this section was added as an afterthought to increase the height of the tower, so that an additional “dust” floor (level three) could be added (Whitmore 1989). This theory is supported by the fact that there is no rebate in the internal brickwork walls to support the level three floor, suggesting it had been completed before it was decided to raise the height of the tower.
